Manhole Inspection Summary

Manhole # S25CC_028MH

Insp Date: **11/26/07 11:11 AM**

Location Address: **1005 FREMONT AVE**

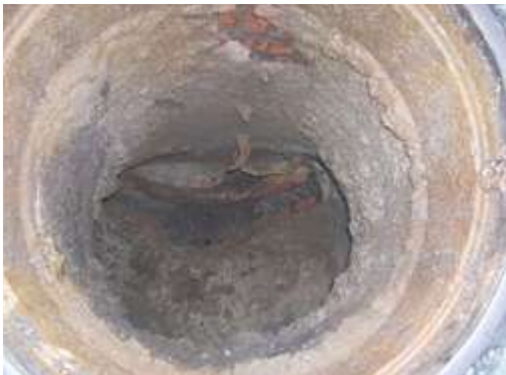
Defect 2

Steps Count: **1** Missing: **3** ☒ Corroded

MISSING AND CORRODED STEPS

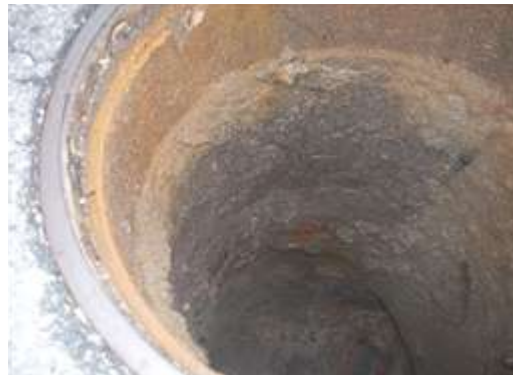
Defect 1

Infiltration: ☐ None ☐ Joint ☐ Cracks ☐ Mortar ☐ Roots ☒ Wall

CORBEL INFILTRATION

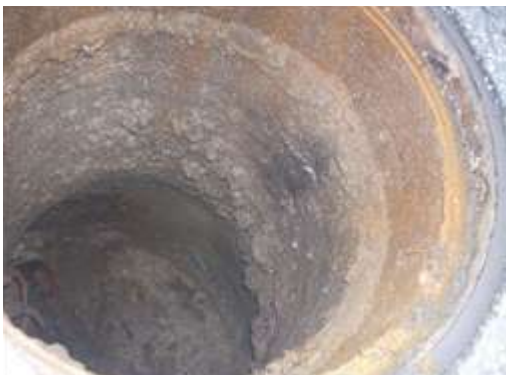
Defect 3

HEAVY MUD ON WALLS

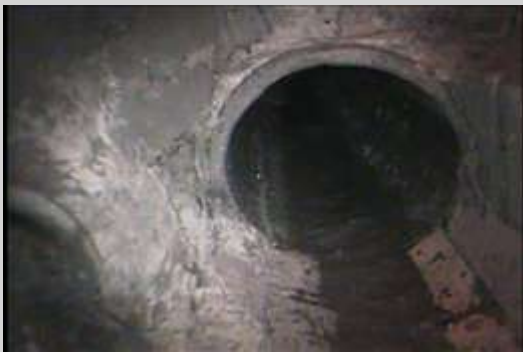
12 O'Clock Outflow

Pipe Height: **8.4** (in.) Rod and Bar (Angled)
Pipe Material: **Clay** ☐ Pipe Lined
Invert Depth: **7.89** (ft.) Flow Characteristics: **None**
Deposits: ☐ None ☐ Mud ☐ Sludge ☒ **Debris** ☐ Grease
Silt Depth: **1** (in.) Deposits Extent: **Light**
Infiltration: **None** Pipe Seal Cond: **Sound**

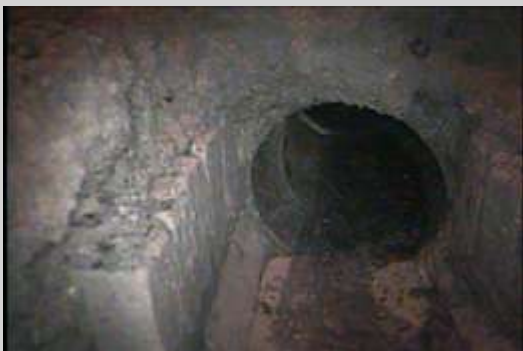
8 O'Clock Inflow

Pipe Height: **7.2** (in.) Rod and Bar (Angled)
Pipe Material: **Clay** ☐ Pipe Lined
Invert Depth: **7.81** (ft.) Flow Characteristics: **None**
Deposits: ☐ None ☐ Mud ☐ Sludge ☒ **Debris** ☐ Grease
Silt Depth: **1** (in.) Deposits Extent: **Light**
Infiltration: **None** Pipe Seal Cond: **Sound**
